W8WWV - Modifications to the Ameritron AL-1200 Amplifier

Greg Ordy

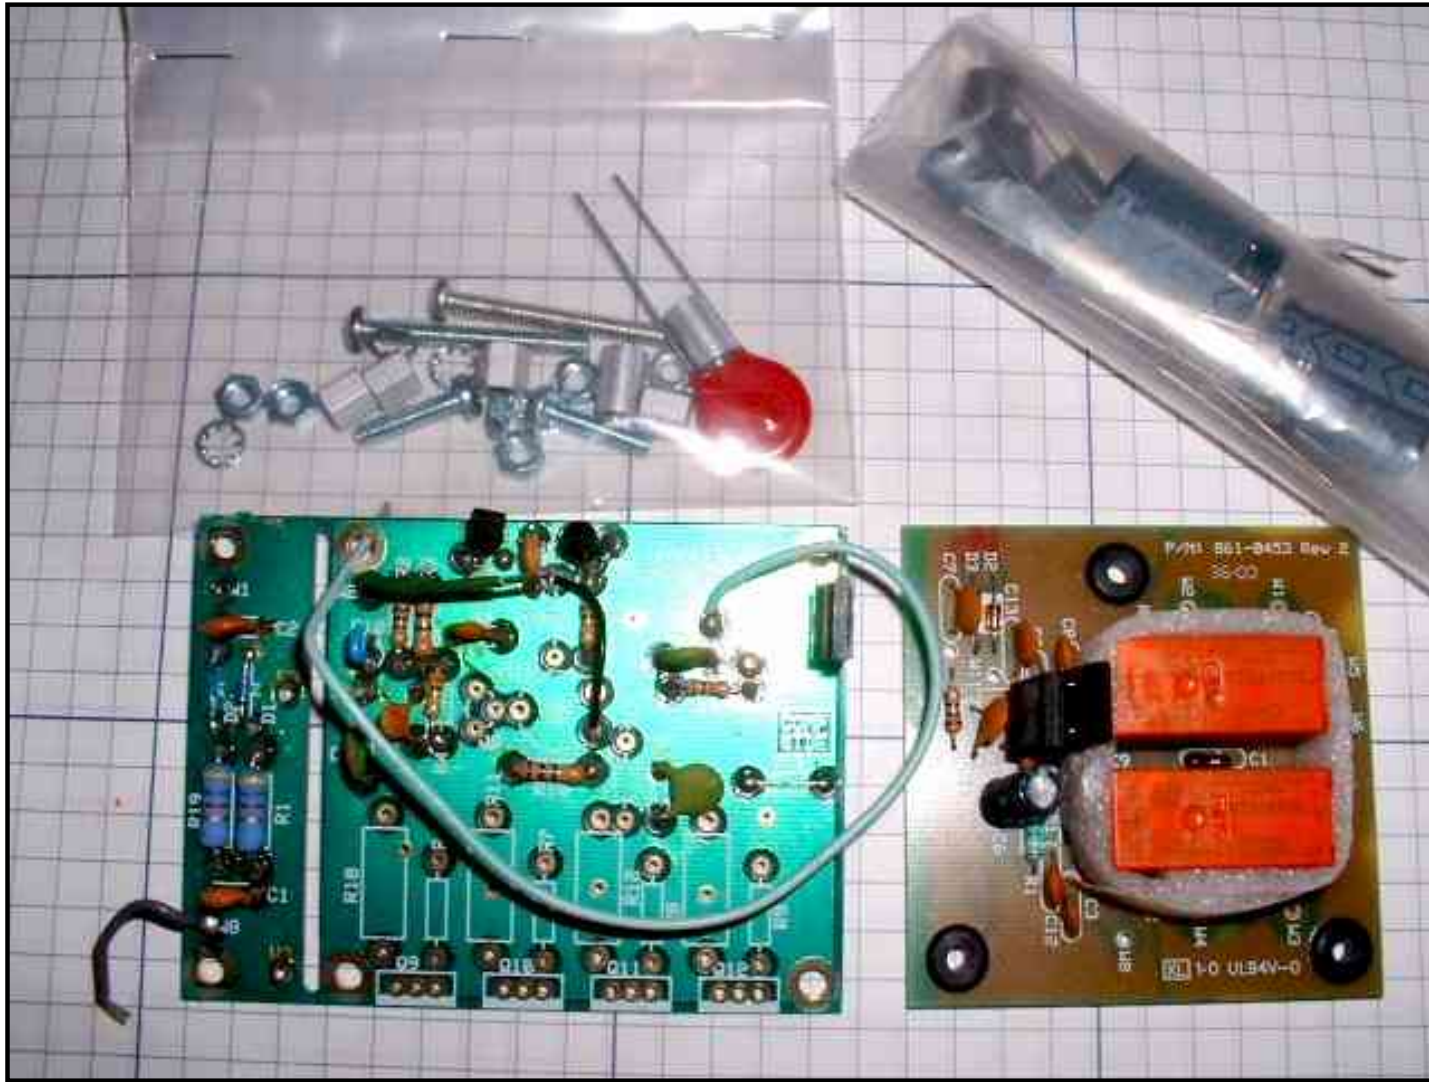
EBS-1 Electronic Bias and Replacement Relay Boards

The boards are shown on top of 1/4 inch grid paper. The parts in the plastic bag above the EBS-1 board (on the left) are the mounting hardware for the board and a MOV. The parts above the relay board include some diodes and filter capacitors used to provide a +25 to +30 Volt DC supply (for the new relays). The relays are enclosed in the orange cases.

The electronic bias modification is called the EBS-1, and cost approximately \$40 (USD, 2002). The new relay board cost approximately \$35 (USD). The relay board appears to be a recent addition, and does not (yet) have a specific part number (but there is a board number, see the relay board section). Here is a picture of the two small circuit boards, shortly after they arrived.

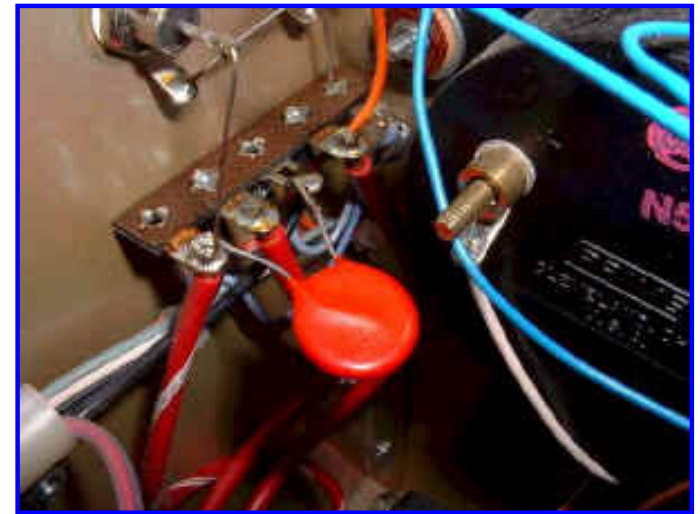
The EBS-1 kit includes a 50 V MOV which is placed between the filament transformer and ground. Although not discussed in the written circuit description, one assumes that this MOV provides some additional circuit protection that relates to the EBS-1 modification (the documentation notes that the maximum open circuit voltage is 50 volts, which happens to be the rating of the MOV). The instructions concerning this part are rather terse. Step 10 simply states: *Solder the red MOV between the filament transformer terminal containing the bare wire to the zener diodes and the ground lug of the terminal strip.* My first question was: *What terminal strip?* Up to this point, all of the attention was directed at the terminal strip near the mid-rear of the center divider. Where is *this* terminal strip? Fortunately, the filament transformer is near the front of the case, and directly above it was a terminal strip with the transformer secondary wires destined for the tube. The center lug was grounded, and had no connections. The lug near the rear was the center tap of the secondary, since it was a red wire with a white stripe, as opposed to the other two plain red wires. In addition, the center tap wire connected to a bare wire that actually was one end of the zener diode bolted to the center divider. In the end, the instructions and the amplifier made sense, but I wish that the documentation was a little more clear on this point.

Board mounted with wiring complete.

Mystery MOV on front terminal strip.

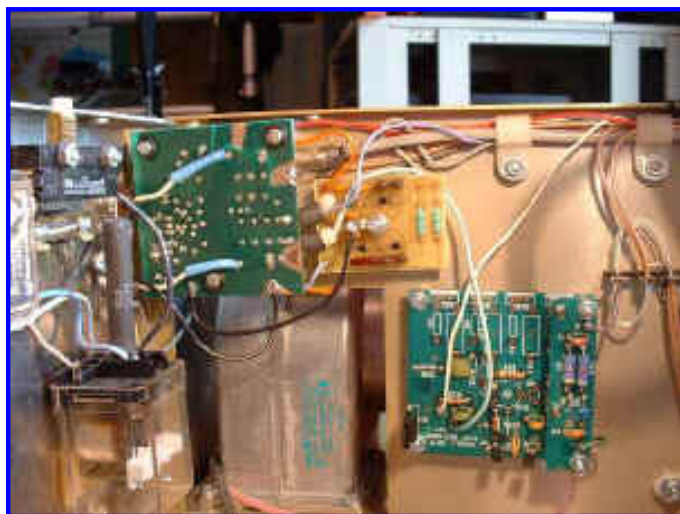
In this case, after considering the location of the wiring points on the board, and the position and length of the wires removed from the mechanical relay, I decided to mount the relay board with the bottom side facing into the open area of the cabinet, and the parts pointing towards the center divider. That may seem strange, but in the end, it worked out well. By the way, the instructions do not indicate where or how to mount the relay board. I made this decision because this orientation made it possible to reuse all of the existing wires that previously were connected to the mechanical relay. I certainly didn't want to start running 1500 watts of RF all over the place, for no good reason.

In order to hold the board in that orientation, I needed to use some long spacers. Fortunately, I had a nice supply of nylon spacers, threaded for 4X40 bolts. Sadly, the stand-off distance is critical. If you make it too short, the 2N3055 transistor on the board will touch the center divider. If you make it too long, the board will hit the center pins on the rear-panel coax (SO-239) connectors. The spacing I used was approximately 7/8 inches.

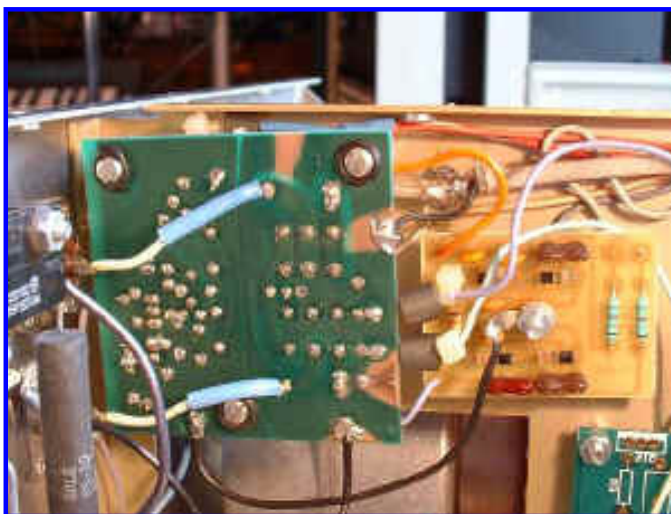
Relay board mounted in upper rear corner of center divider.

Close-up of relay board.

New 24 Volt DC Supply.

The left picture shows the new relay board mounted in the upper rear corner of the center divider. The EBS-1 bias board, described previously on this page, is in the lower right of the picture. If you return to the previous EBS-1 pictures, you can see the mechanical relay. When reassembled, the massive power transformer fills up the open space in the picture.

The middle picture is a close-up shot of the relay board. The white wires moving off to the left are the connections to the SO-239 UHF jacks. The upper wire is the RF-out, and the lower wire is the RF-in. The blue heat shrink near the board keeps those connections well-insulated. Except for several black ground wires visible on the edges of the board, all of the remaining connections are made with the wire entering from the component side of the board, coming through the holes to the trace side of the board. I soldered several of the wires to the trace side before mounting the board. There was enough slack in the lines to allow a small degree of movement. I then mounted the board with 3 screws and completed the remaining connections. Mounting and wiring the board took several hours. Even detailed instructions would not have helped. It is simply tedious to make sure that you are getting it correct. It's a small and cramped area. While I removed the transformer for the EBS-1 modification, I believe that you would also want to remove it to add the relay board.

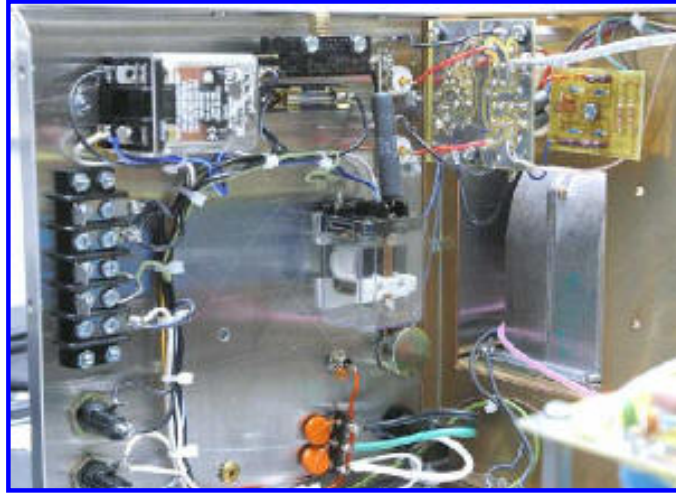
New Power Supply Board

The additional DC power supply is shown in the above right picture. The bottom of the board is mounted to the bottom of the cabinet via an aluminum **L** bracket. The first component on the bottom of the board is the 12 VAC to 120 VAC transformer. Directly above it is the 120 VAC to 24 VAC transformer. The top of the board

contains a terminal strip with the full-wave bridge rectifier, and a large filter capacitor. I also put a 0.01 uF capacitor across the output voltage in order to provide RF suppression. For additional mechanical support I made up a ground strap that went between the top of the filter capacitor bank, and the new power supply board. This strap was less than an inch of 12 gauge solid wire. It is very stiff, and insures that the power supply won't wiggle in the cabinet.

The following picture shows the new power supply board mounted in the cabinet. If you look closely, you can see the ground strap going from the front corner of the filter capacitor bank to the new board.

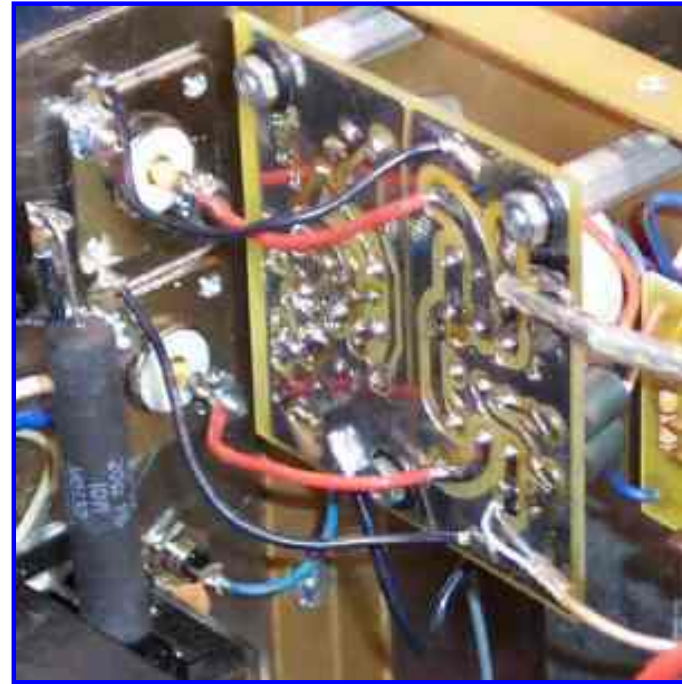
Factory Installed New Relay Board (courtesy of K5JP)

Relay Details (courtesy of N5TML)

I was very glad to see that I installed my board in the same orientation as the factory. You can also see two of the mounting holes for the EBS-1 board on the right edge of the picture.
